INTERIM MEASURES COMPLETION REPORT

**McDonnell Douglas Aerospace
U.S. EPA I.D. No. MOD000818963
Tract I Facility
Hazelwood, Missouri**

**Heritage Environmental Services, Inc.
Chicago Division
15330 Canal Bank Road
Lemont, Illinois 60439**

December 18, 1997

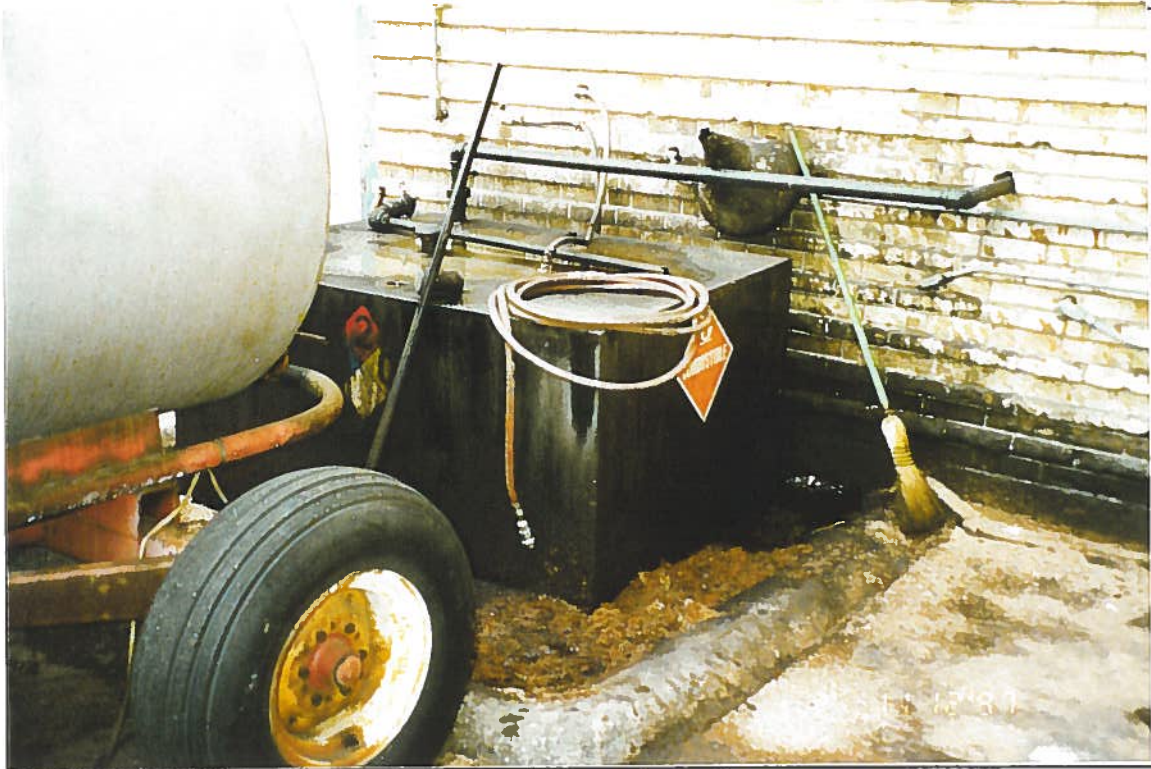
PHOTOGRAPH 1 (ABOVE): View of 375 gallon AST utilized to containerize recovered compressor oil. Vacuum tanker utilized to remove and transport waste compressor oil can be seen at left. Absorbent material is shown within and right of asphalt constructed secondary containment berm for AST.

- ▶ Liquids were removed from the AST utilizing a vacuum truck and suction hose. Vacuum equipment and AST were static grounded to prevent static discharge during the transfer activities.
- ▶ After completion of the removal of the waste oil from the AST, the interior atmosphere of the AST was monitored for LEL, O₂, and hydrocarbon vapors (ppm) utilizing a GasTech® meter to evaluate the AST interior atmosphere for potential hazardous conditions.
- ▶ The top of the AST was cut open utilizing a 30-pound pneumatic chisel hammer.

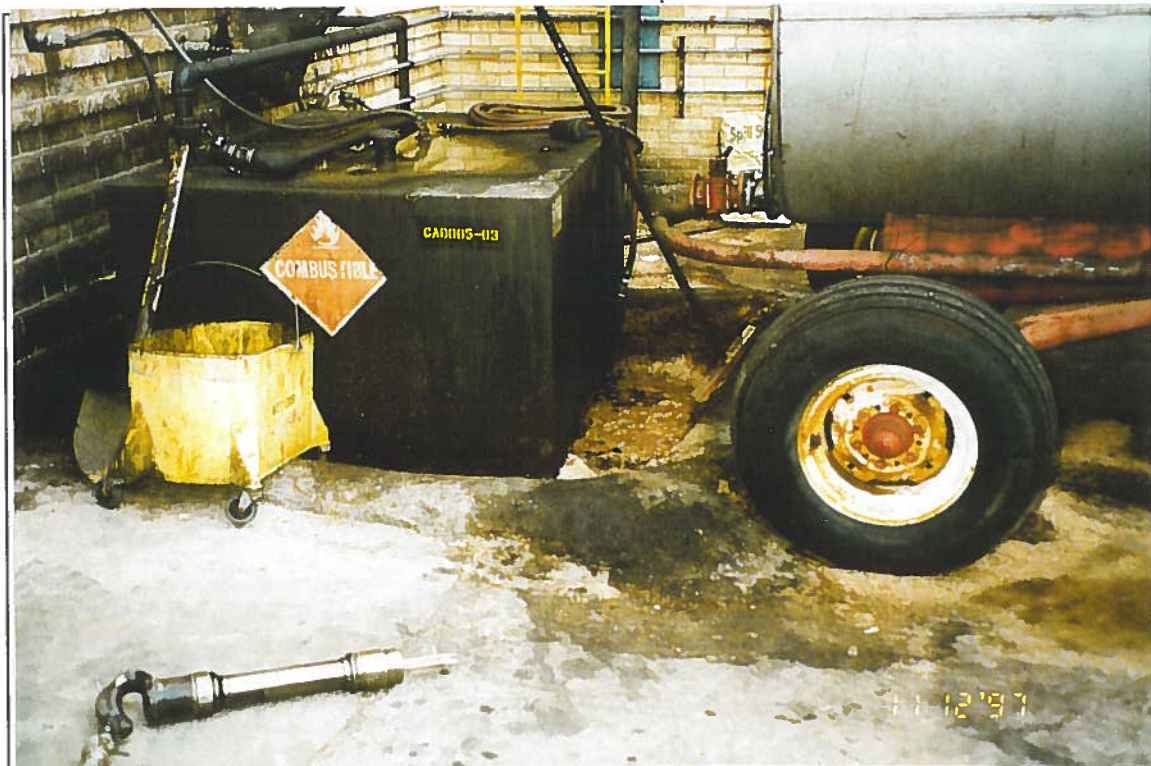
PHOTOGRAPH 2 (BELOW): Additional view of waste compressor oil AST. Pneumatic chisel hammer utilized to cut open the AST can be seen at lower left.

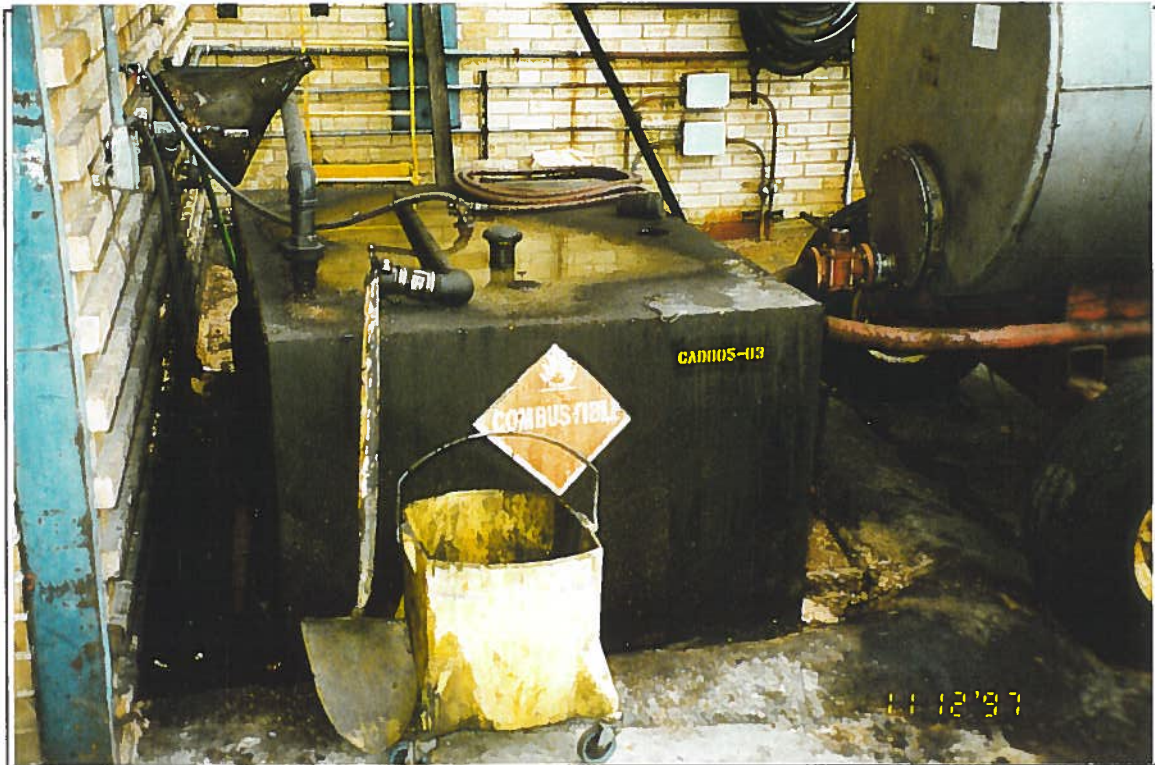
PHOTOGRAPH 3 (ABOVE): Close up view of AST.

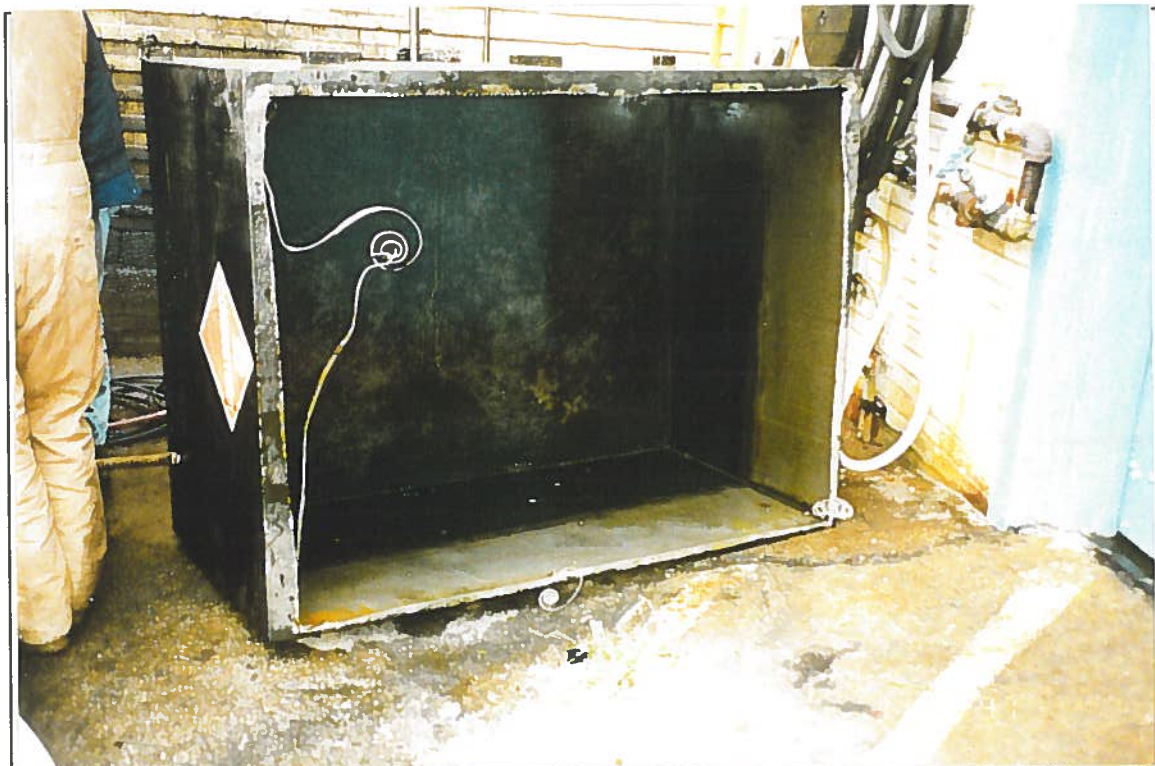
PHOTOGRAPH 4 (BELOW): View of AST after removal of top and interior cleaning.

- ▶ Scale and tank-solids were removed from the AST interior. The interior was cleaned utilizing a citra-clean solution and high-pressure water rinse.
- ▶ Tank cleaning rinseates were removed from the AST utilizing a drum vacuum and suction hose and containerized in a steel 55-gallon drum.
- ▶ The asphalt constructed secondary containment berm and concrete surface underlying the AST was cleaned utilizing a low pressure citra-clean and water solution wash. Subsequent to the surface cleaning activities, the berm was removed and containerized into a steel hoppers.
- ▶ After completion of the asphalt removal activities, the exposed concrete surface was final-cleaned utilizing a high pressure water wash. The former AST area, after completion of the cleaning activities, is shown in Appendix 1, Photograph 6.

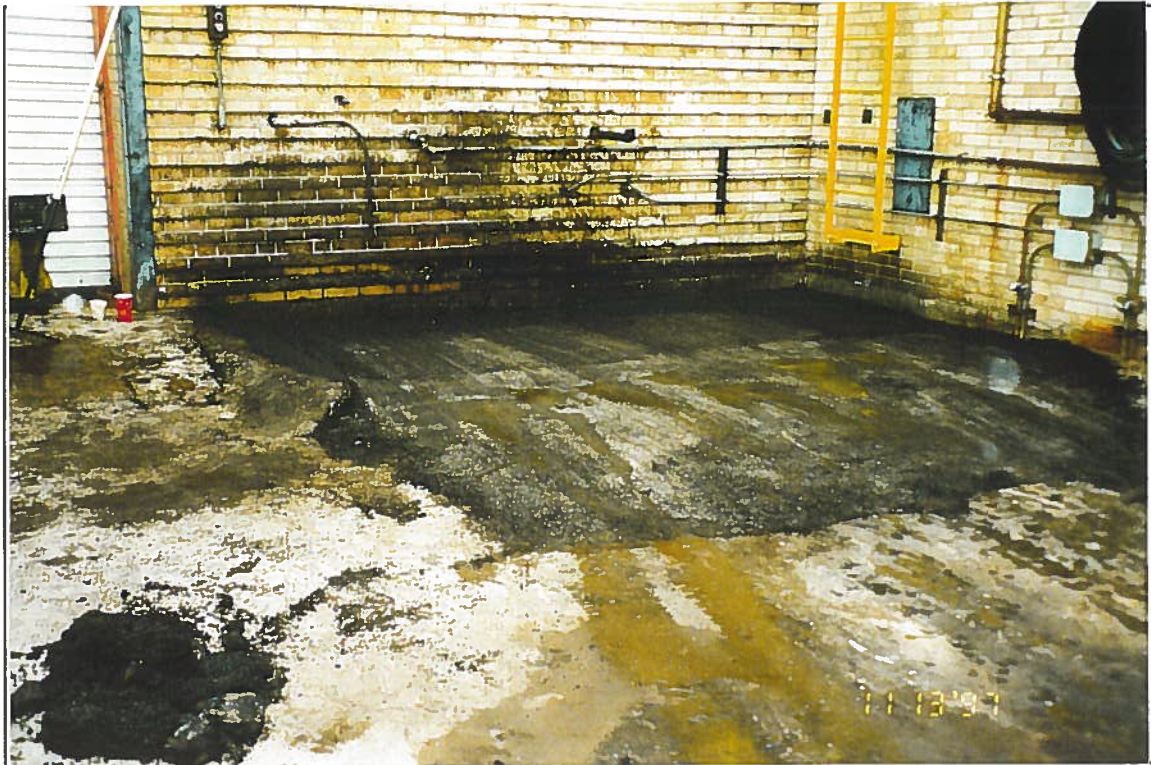
PHOTOGRAPH 5 (ABOVE): View of removal of asphalt secondary containment berm.

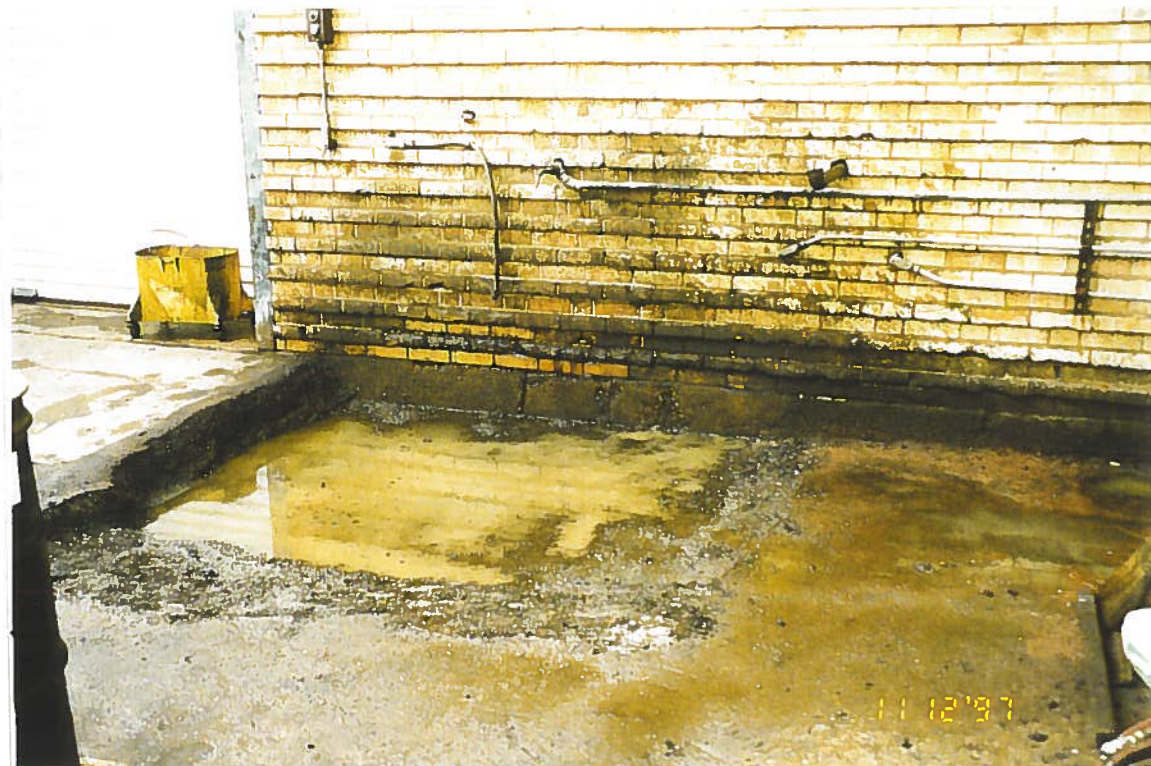
PHOTOGRAPH 6 (BELOW): View of former AST area after completion of area cleanup. Rough surface in concrete pad is the result of high pressure water (scrabbling").

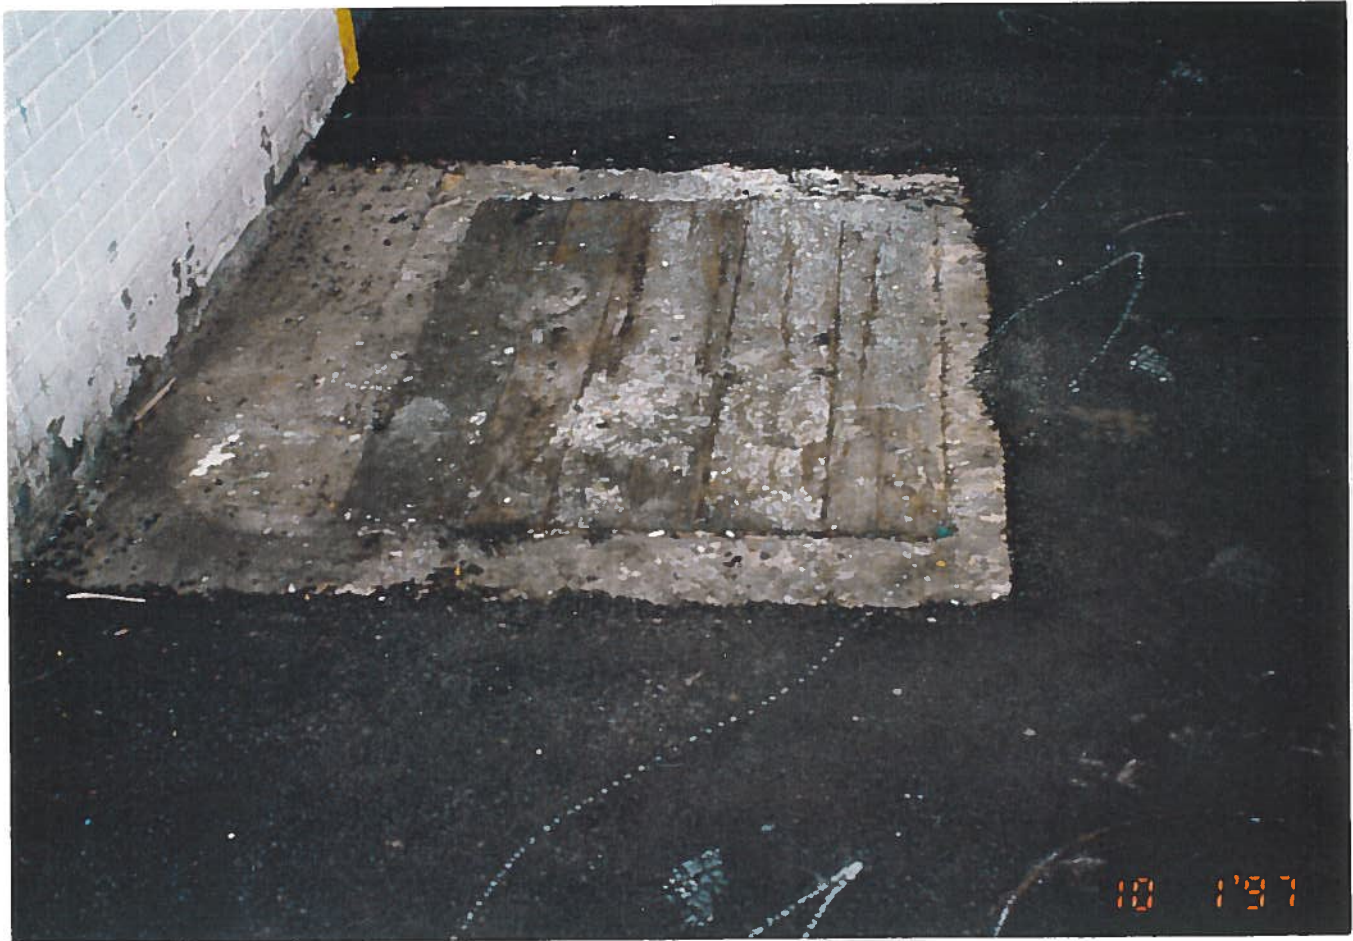
PHOTOGRAPH 7 (ABOVE): View of abandoned sump prior to investigative activities. Placement of new asphalt surface material can be seen around perimeter of sump. Asphalt resurface measured approximately 1 inch thick (compressed).

Interim Measure Activities at this SWMU included the placement of an additional lift of asphalt surface cover material to effectively seal existing cracks in the former surface grade. The surface area covered by the resealing activities measured 25 ft. by 25 ft. (625 square feet). Approximately 1-inch lift of compressed asphalt was utilized as a surface seal.

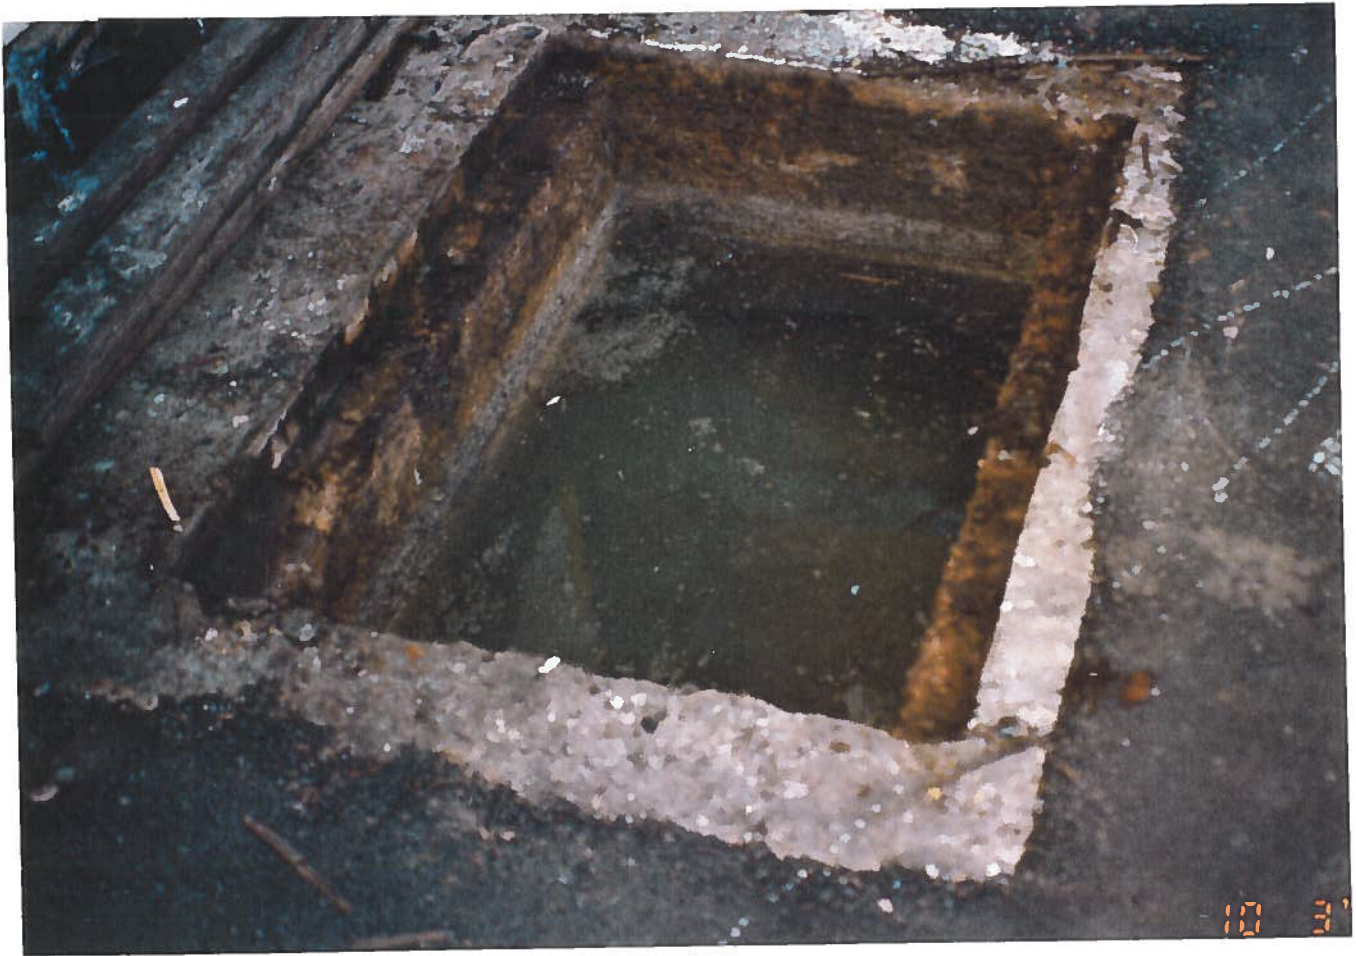
Investigation of the abandoned sump on October 3, 1997 identified the sump to be a former stormwater drain trap. The stormwater trap measured 48-inches by 30-inches. The base of the sump was 51-inches below surface grade. Upon removal of the wood-timber surface cover, the sump was found to contain approximately 19-inches of standing water overlaying approximately 21-inches of liquid-sludge.

PHOTOGRAPH 8 (ABOVE): View of sump after removal of boards.

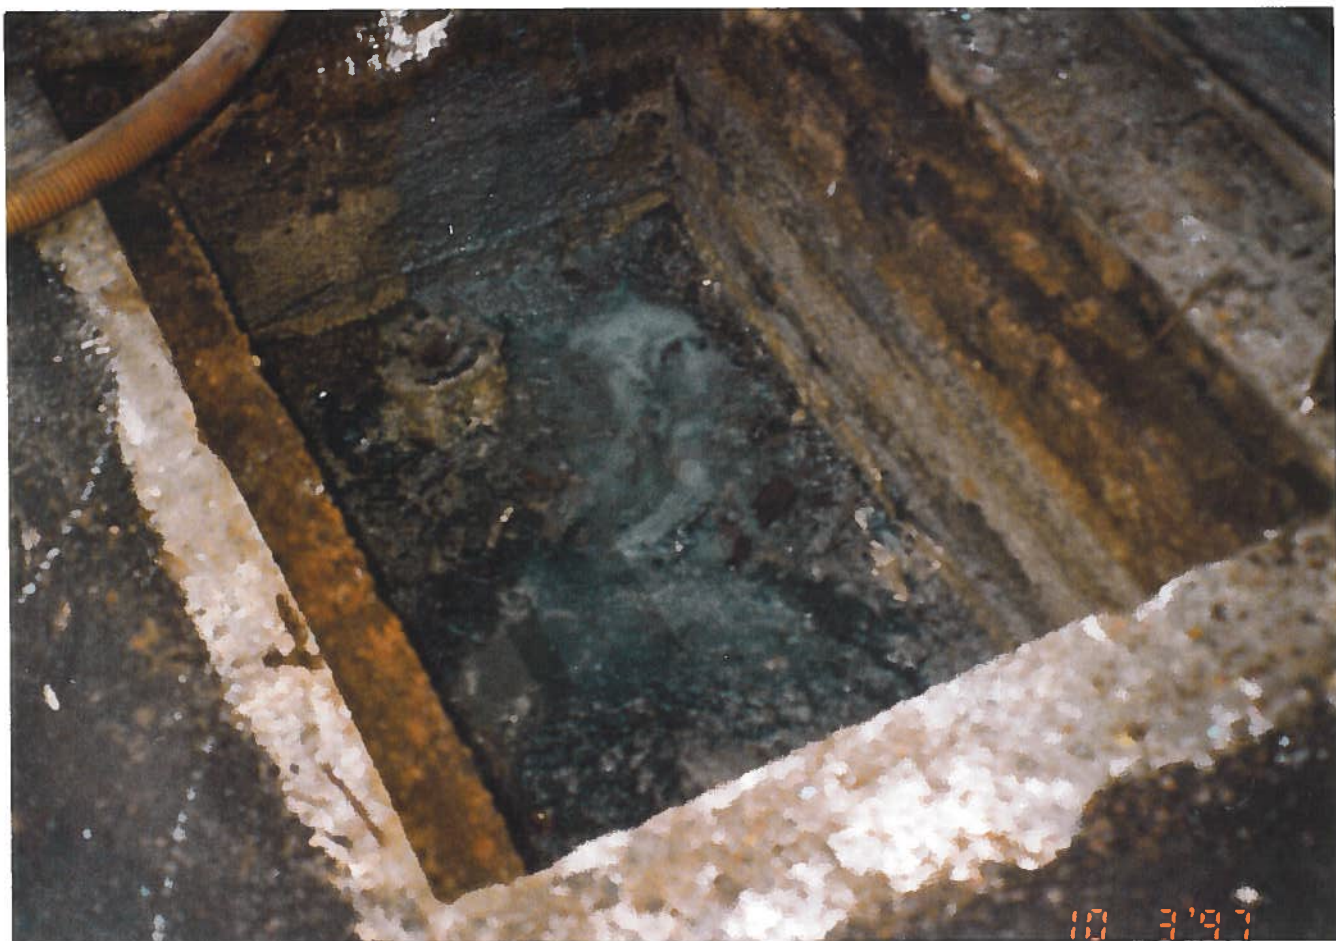
PHOTOGRAPH 9 (ABOVE): View of sump at SWMU #22 after removal of standing water and exposure of underlaying solids surface.

Water and sludge were removed from the sump utilizing a drum vacuum and suction hose. Removed sludge was containerized in a steel 55-gallon drum. The sump was final washed utilizing a low pressure citra-clean and water solution wash followed by a high-pressure water rinse.

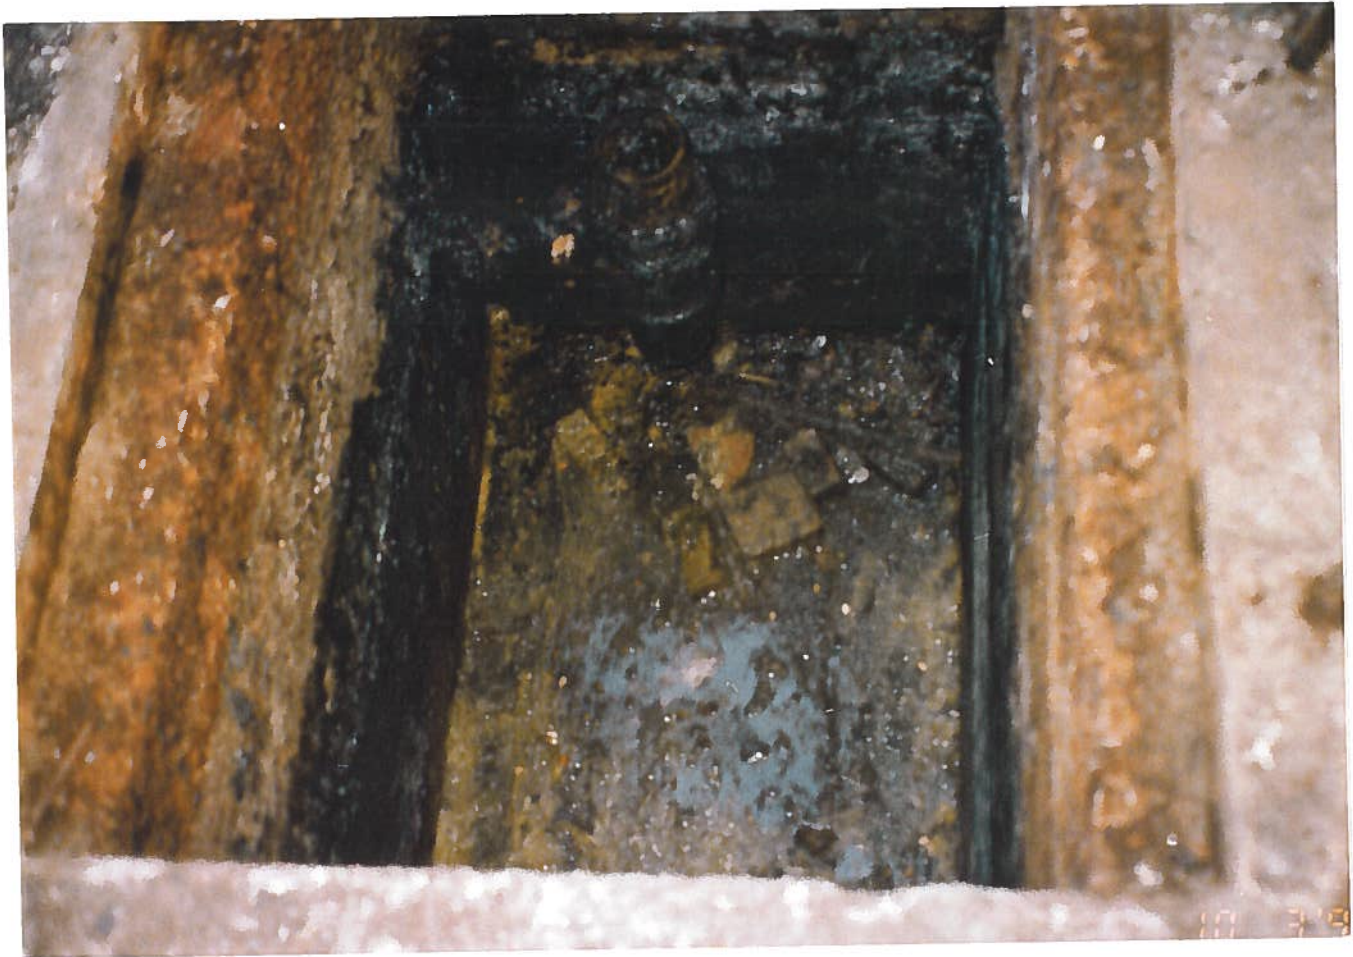
PHOTOGRAPH 10 (ABOVE): View of sump at SWMU #22 after removal of solids.

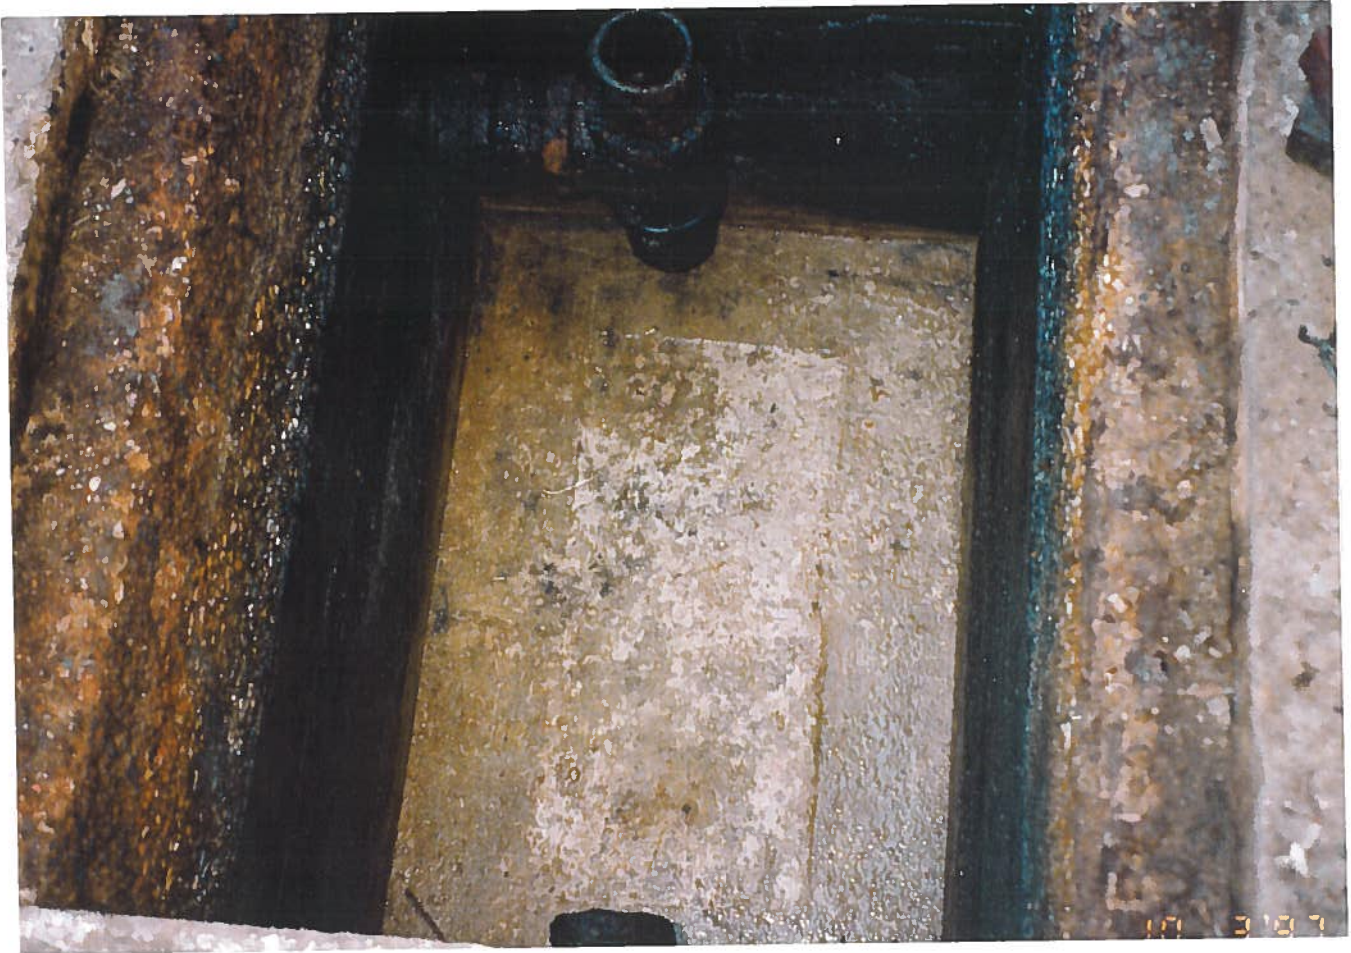
PHOTOGRAPH 11 (ABOVE): View of sump at SWMU #22 after completion of final clean up of sump floor, walls, and exposed piping.

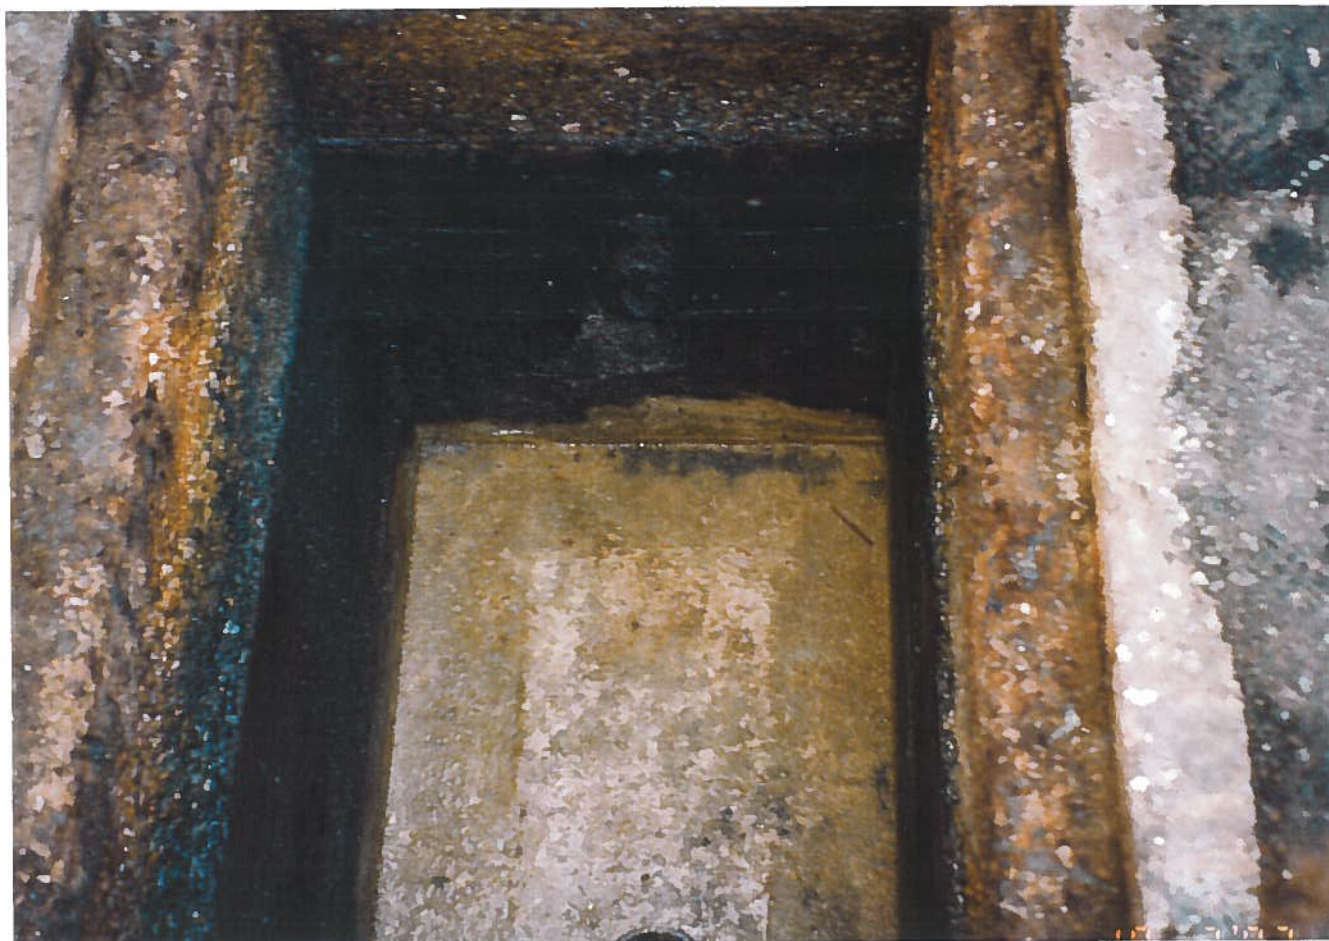
PHOTOGRAPH 12 (ABOVE): Additional view of sump at SWMU #22 after completion of final clean up of sump floor, walls, and piping. Note piping at top of photograph was capped at time of previous abandonment.

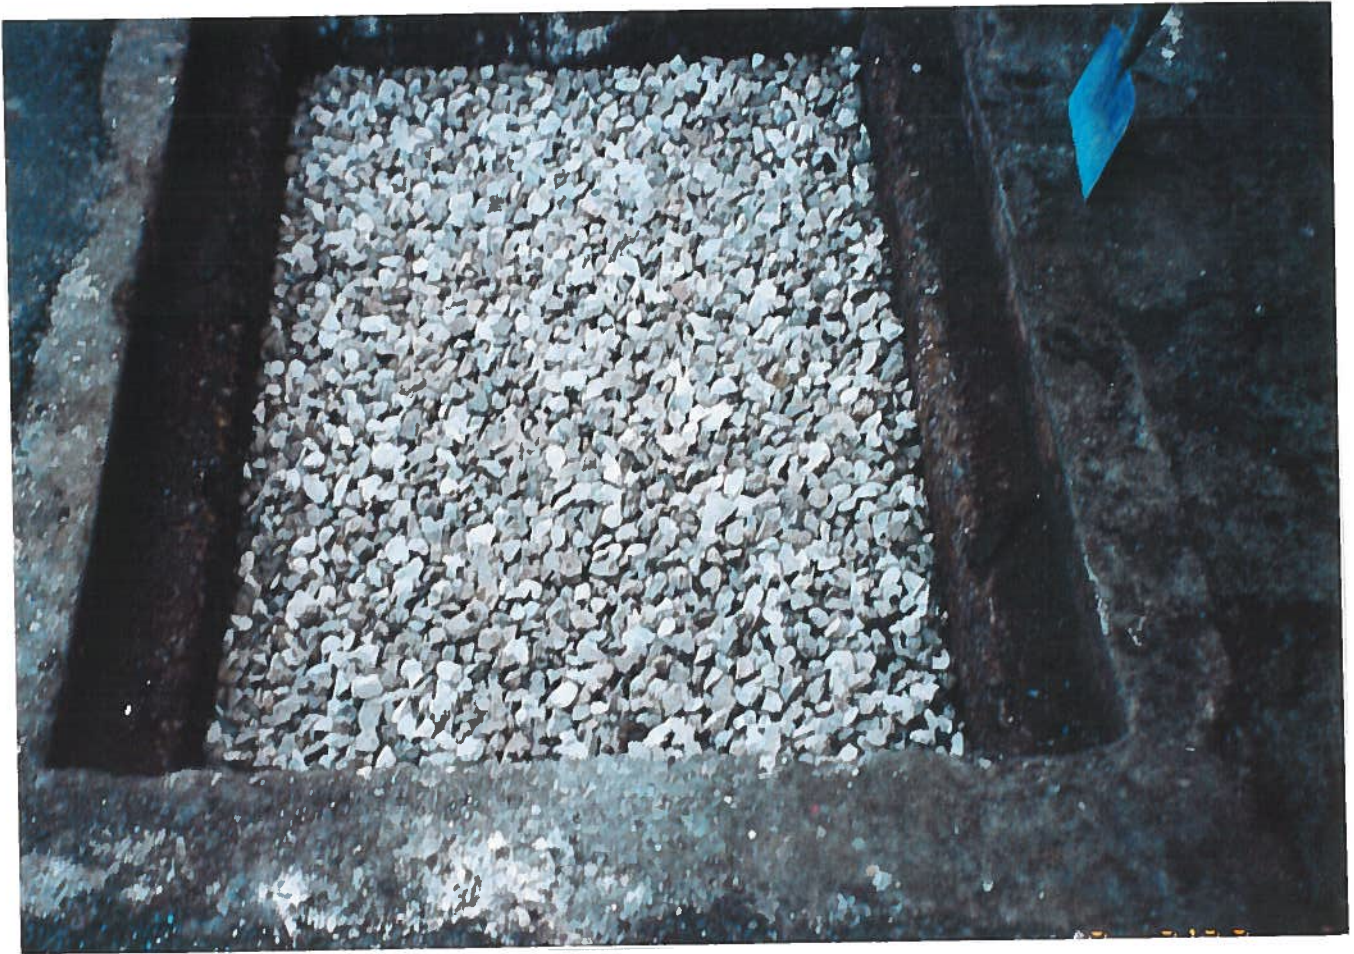
PHOTOGRAPH 13 (ABOVE): View of sump at SWMU #22 after placement of granular rock backfill and prior to concrete surface pad.

After completion of the cleaning activities at the sump, the sump cavity was backfilled with 1-inch clean stone to 6-inches below surface grade. The sump was sealed at surface grade utilizing a 6-inch poured-concrete pad. Photographs of the sump area during the cleanup activities are shown in Appendix 1, Photographs 7 through 14.

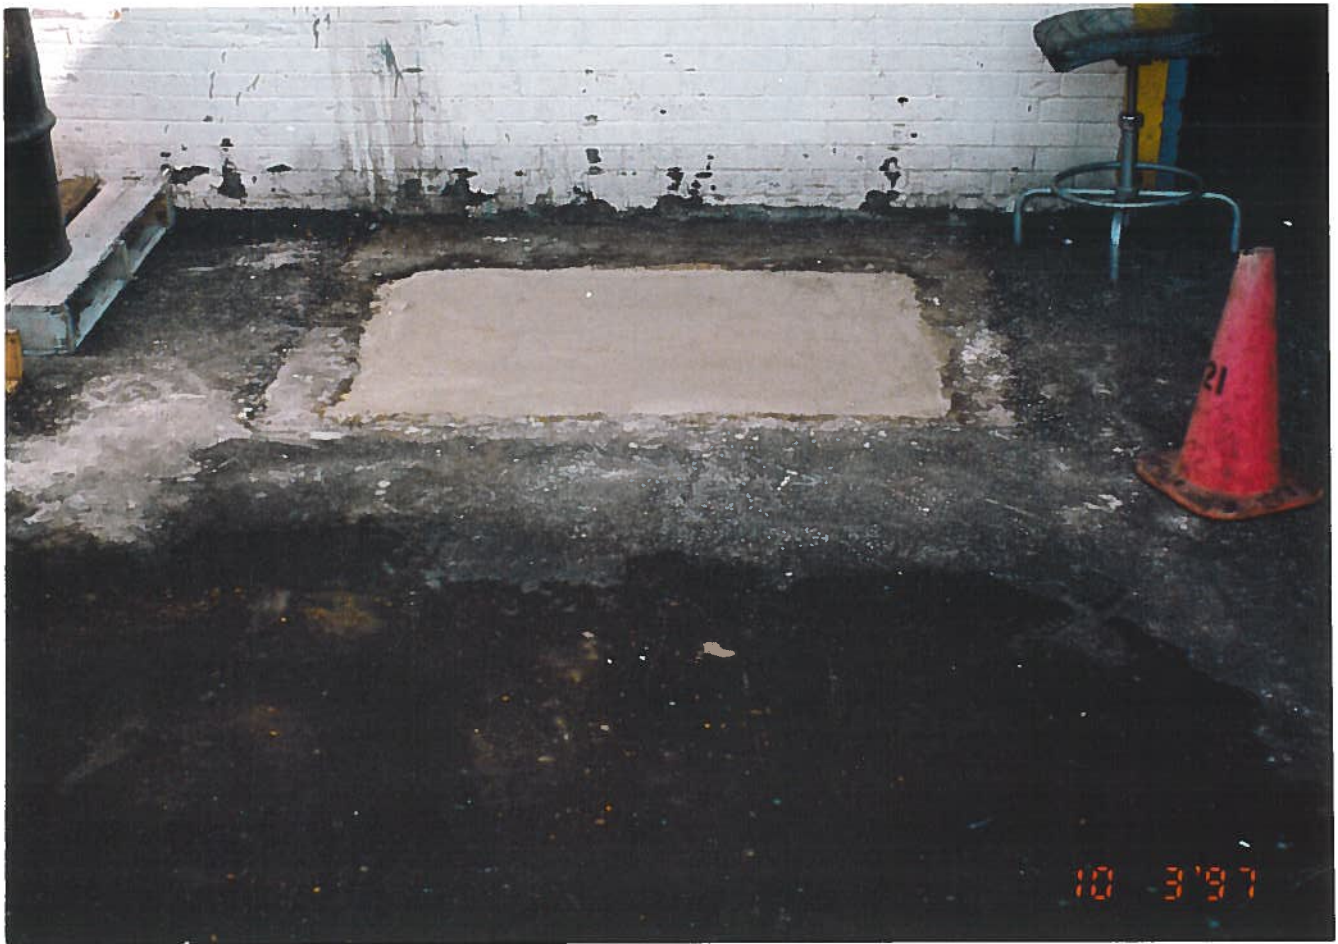
PHOTOGRAPH 14 (ABOVE): View of sump at SWMU #22 after placement of concrete surface pad.

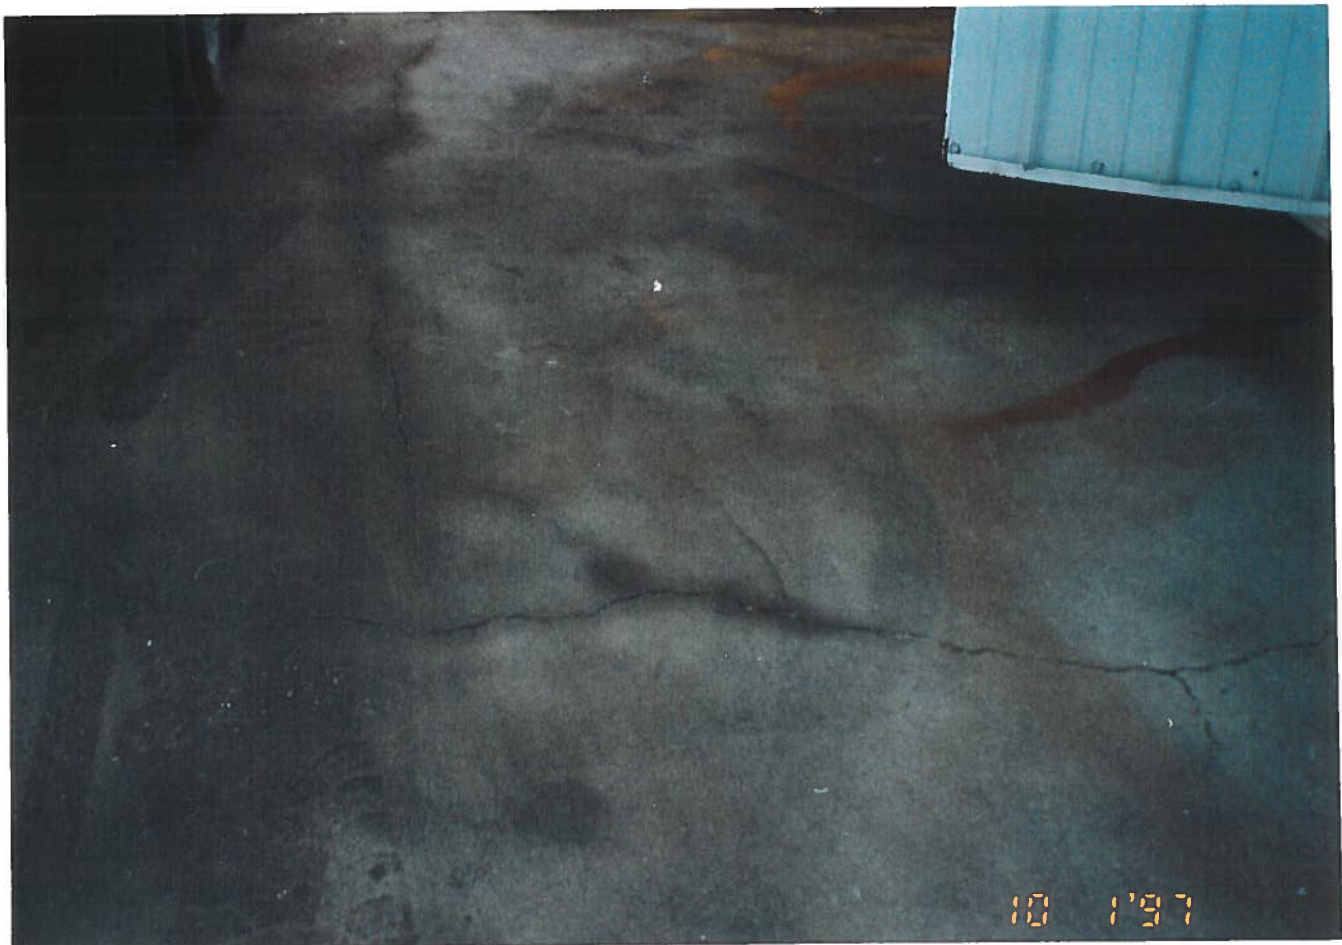
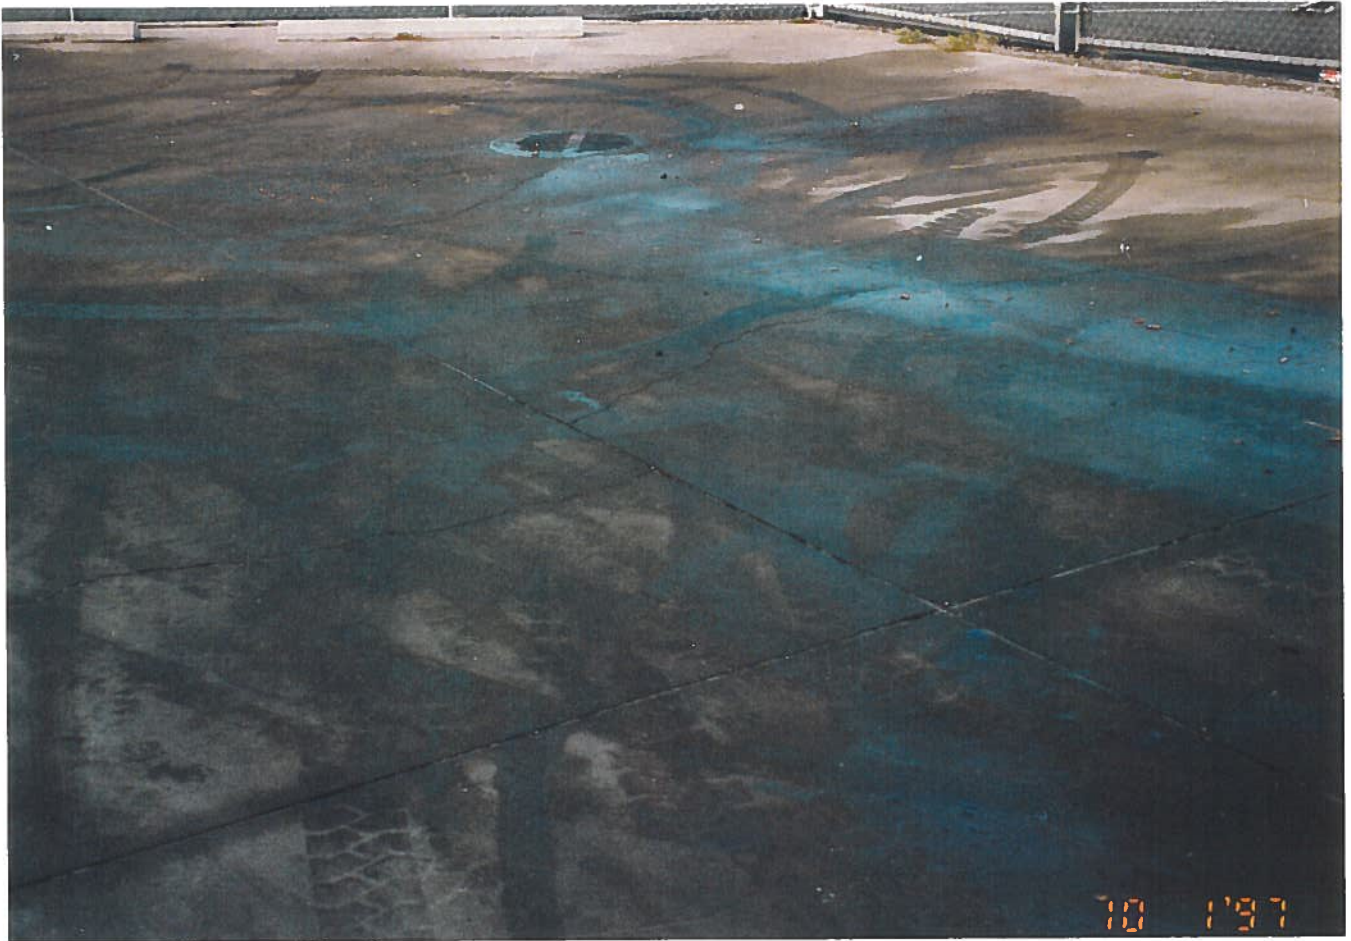
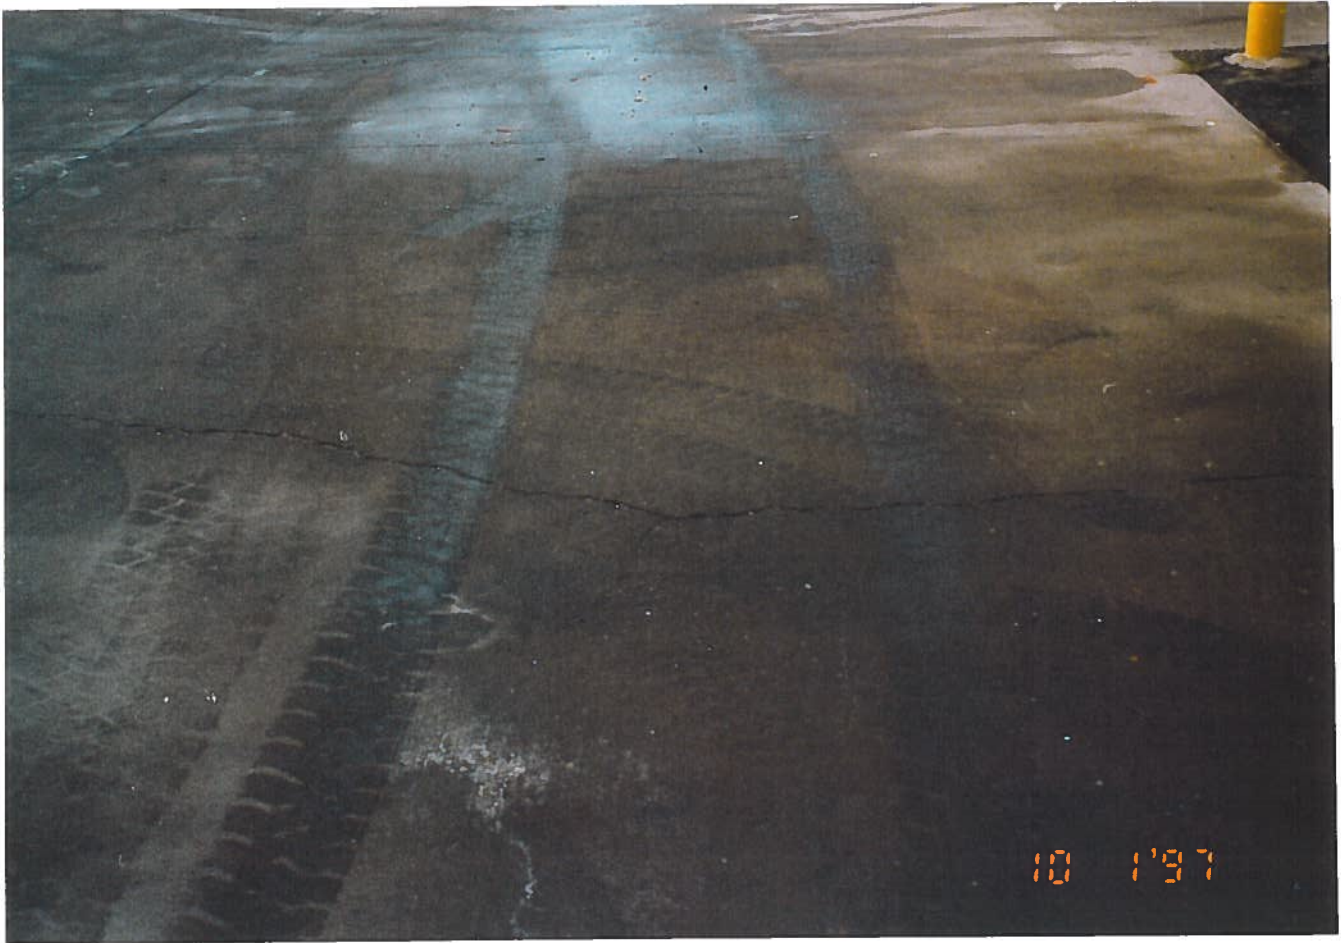
Specific concerns for this SWMU were the potential for impact of paint solvents to underlying soil and groundwater as a result of existing cracks in the concrete surface cover at the former SWMU.

PHOTOGRAPH 15 (ABOVE): View of surface cracks in concrete surface at SWMU #26 prior to cleaning and sealing.

On October 10, 1997, cleaning and sealing activities were performed at former SWMU #26. Existing surface cracks were cleaned of loose materials utilizing a high pressure water wash and dried utilizing compressed air.
